WHITE MESA URANIUM MILL

LICENSE RENEWAL APPLICATION

STATE OF UTAH RADIOACTIVE MATERIALS LICENSE No. UT1900479

Volume 3 of 5
(License Renewal Application)
(Appendices J-O)

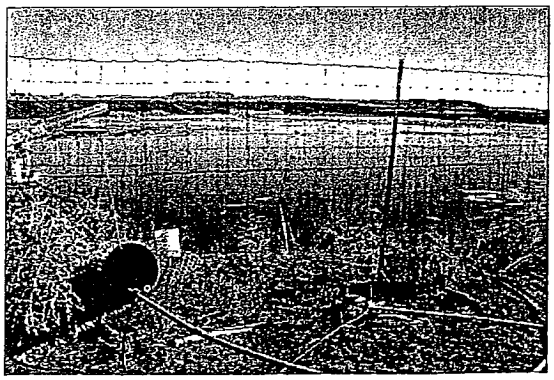
Liner leak detection system at Cell 4-A

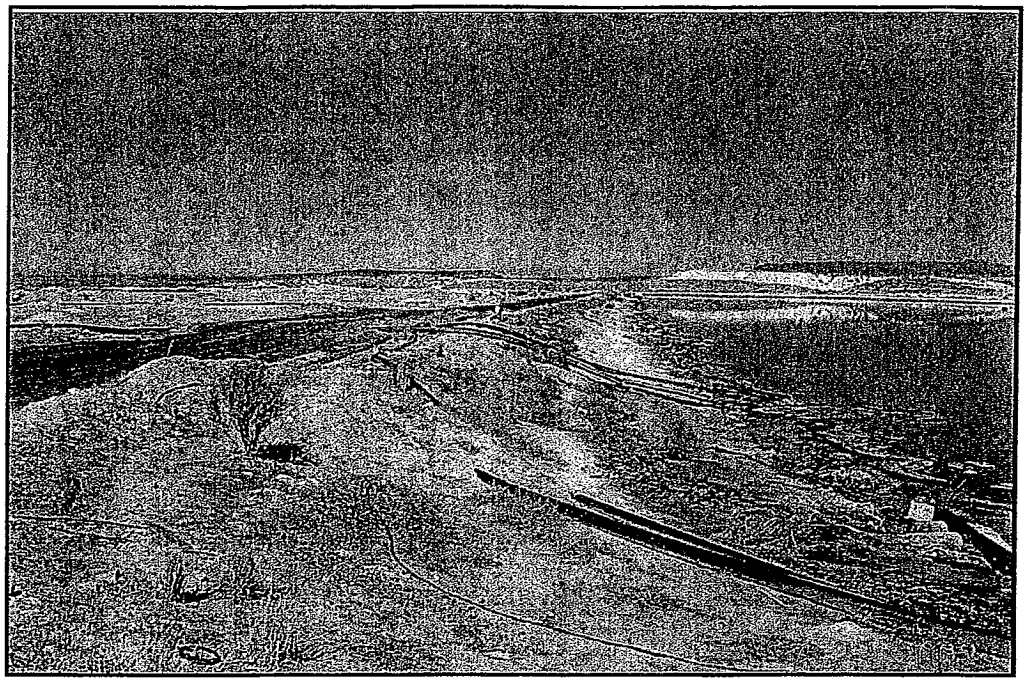
Photo 1. Looking west along Dike 1. Cell 1 is on the right side of the photograph.

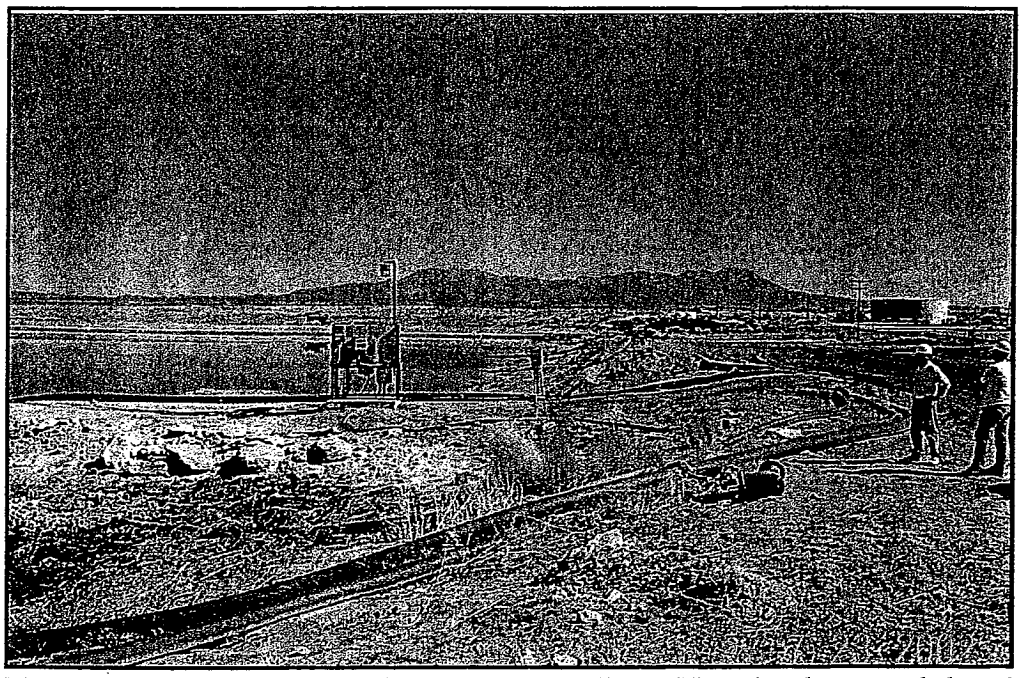
Photo 2. Looking north along the east side of Cell 1-I. Note that the ground elevation is approximately the same as the dike elevation.

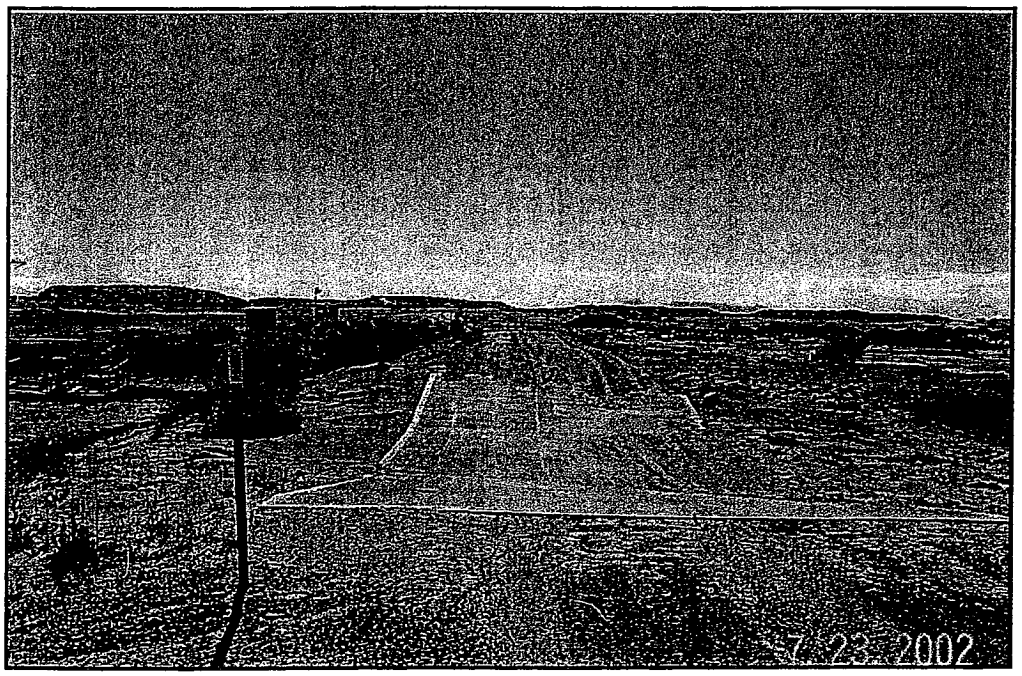
Photo 6. The concrete spillway section located near center of Dike 2 appears to be in good condition. Cell No. 2 is on the left in photo and Cell No. 3 is on the right.

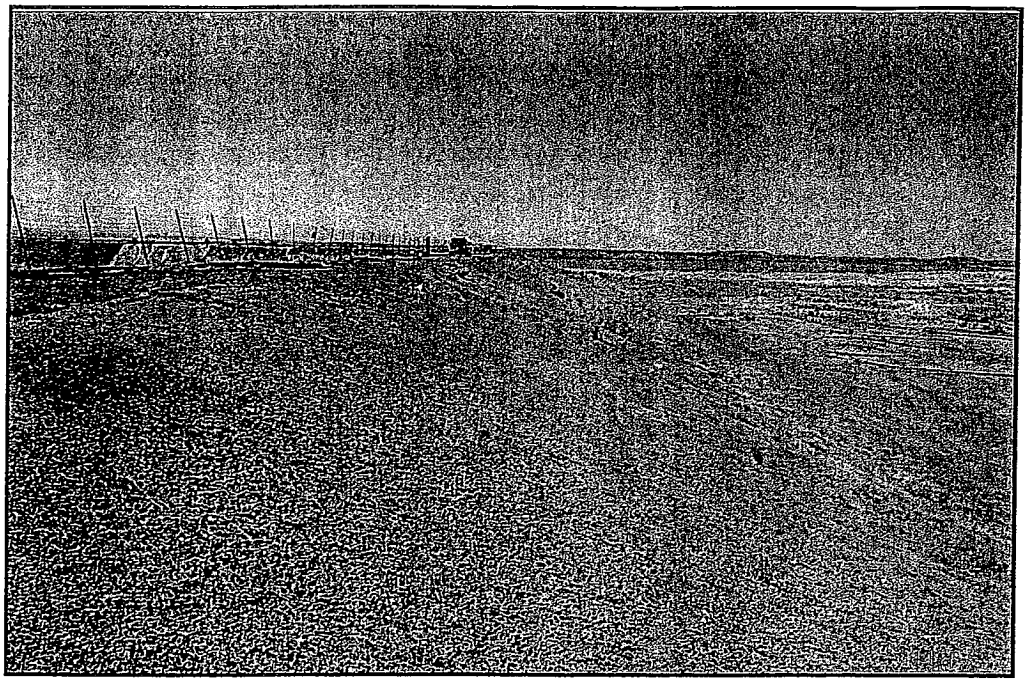
Photo 9. Looking south along the downstream slope of Dike 4A-W. Note the uniform slope, minimal vegetation, and lack of significant erosion.

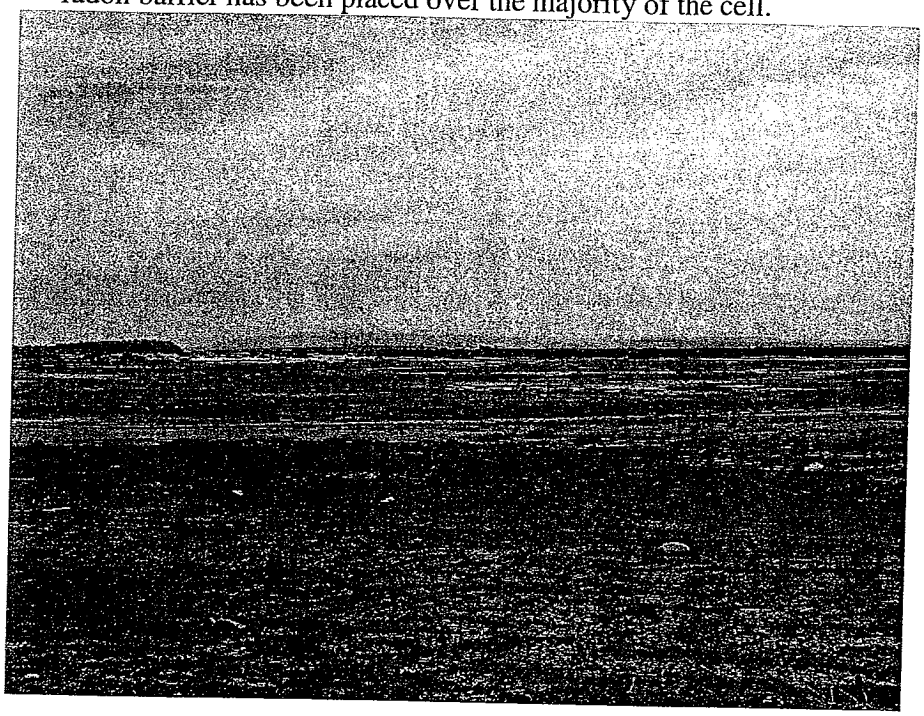
Figure 4: March 22, 2005: Cell 2 viewed from the south embankment. Temporary radon barrier has been placed over the majority of the cell.

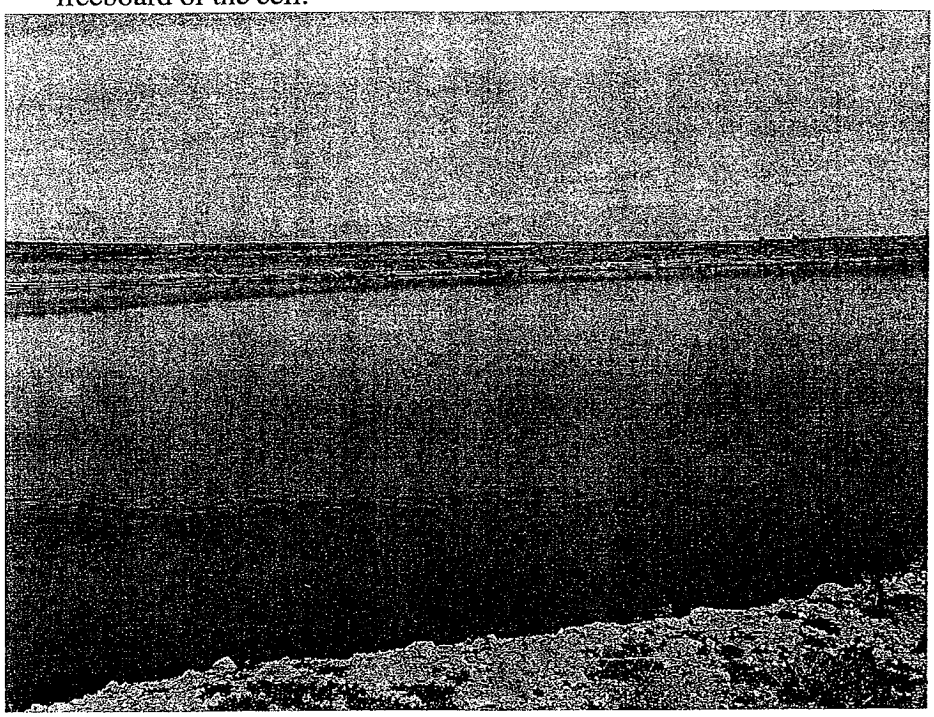
Figure 2: 03/22/05: View of Cell 1 from the south embankment. The band of red is the freeboard of the cell.

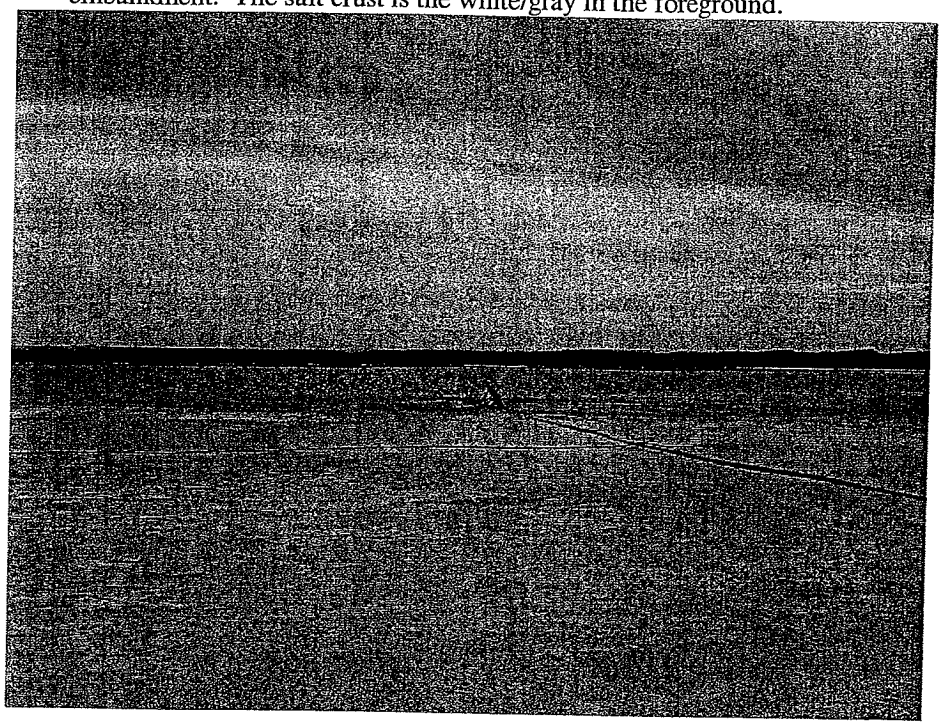
Figure 8: March 22, 2005: Same as Figure 7.

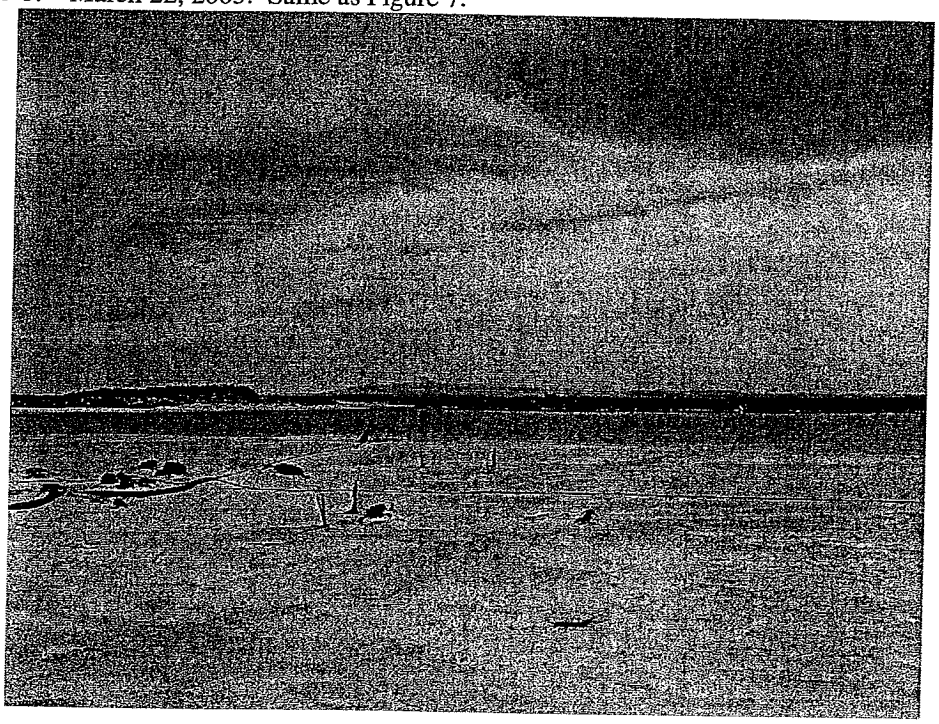
Figure 5: March 22, 2005: Open area of Cell 2 viewed from the south embankment. This portion of the cell is used for facility trash disposal.

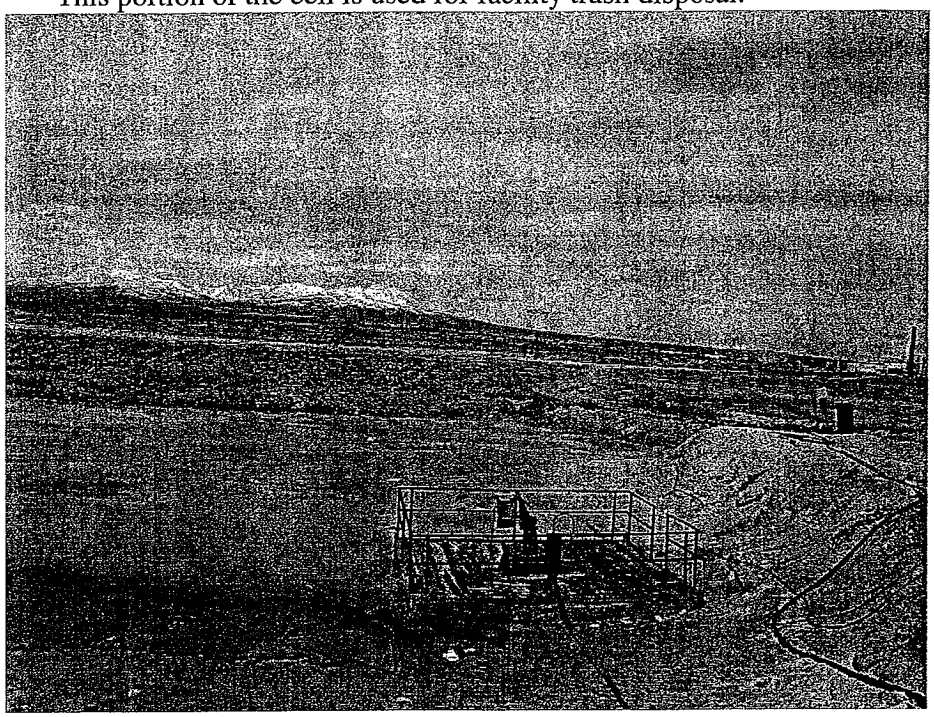
Figure 6: March 22, 2005: Same as Figure 5.

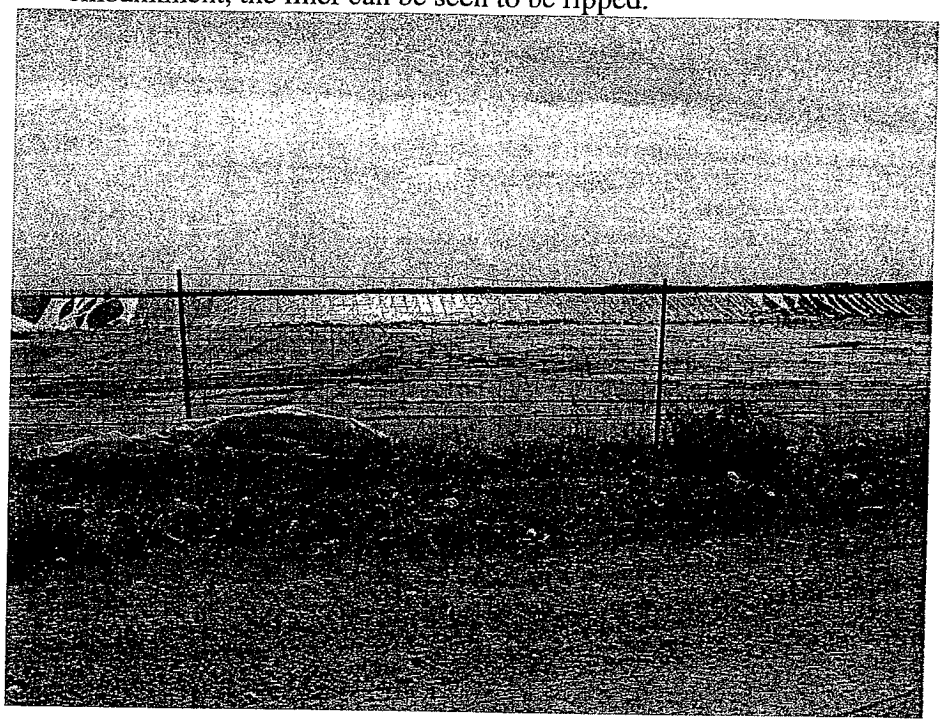
Figure 11: March 22, 2005: Same as Figure 10. On the left and right of the embankment, the liner can be seen to be ripped.

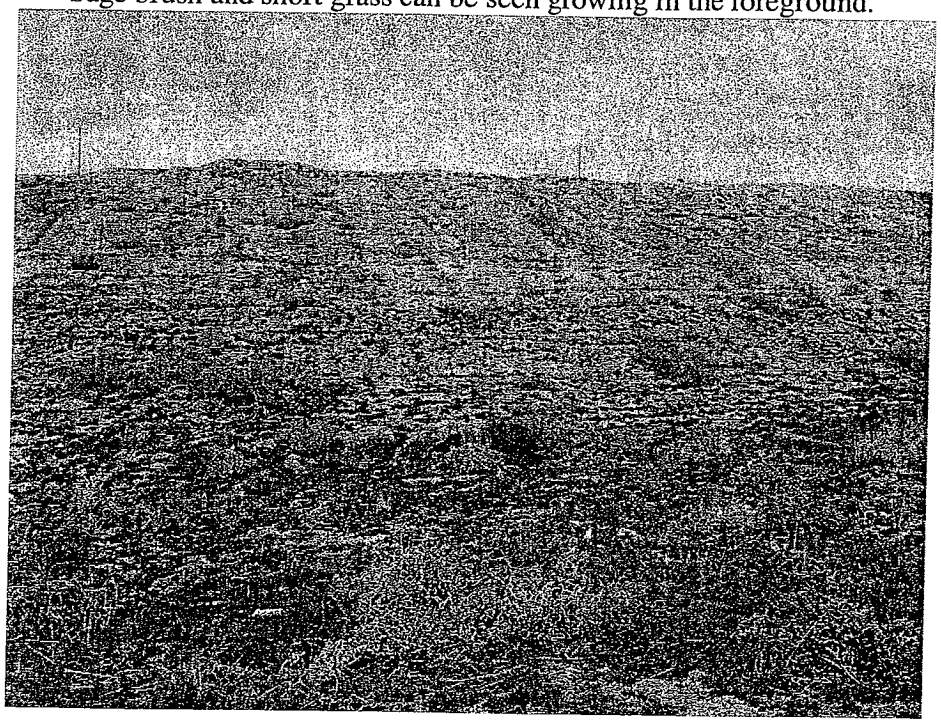
Figure 12: March 22, 2005: Cell 4A downslope embankment viewed from the south. Sage brush and short grass can be seen growing in the foreground.

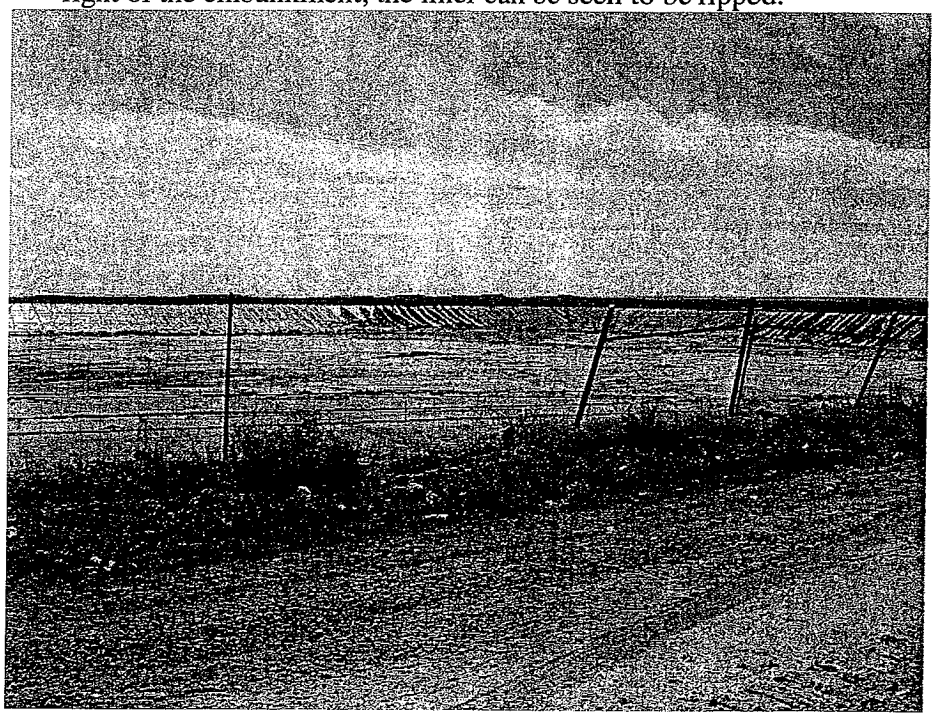
Figure 9: March 22, 2005: Cell 3 downslope embankment viewed from the east. Sage brush and short grasses are growing on the slope.

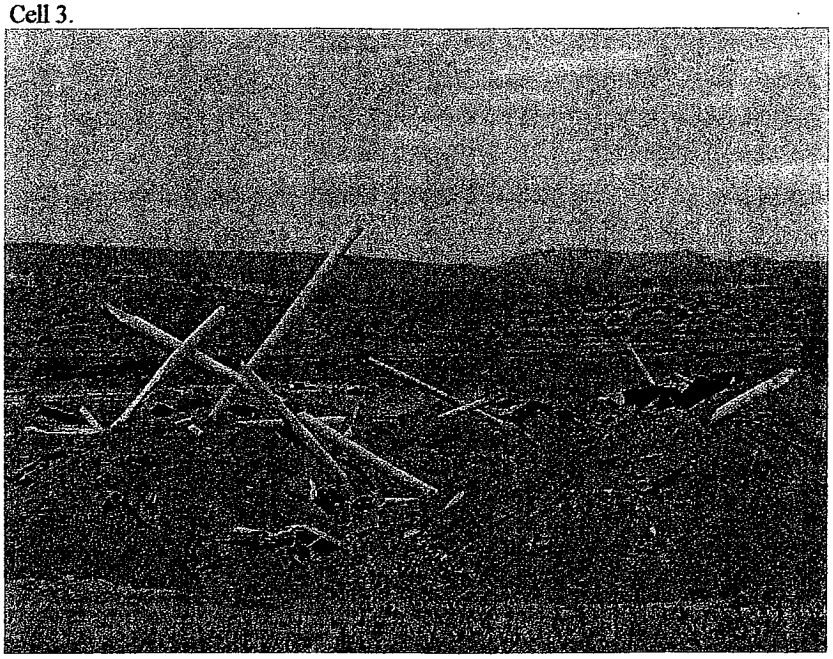
Figure 1: 09/20/05: Cell 4A Leak detection system has been cleaned up and is waiting for final disposal in tailings Cell 3.

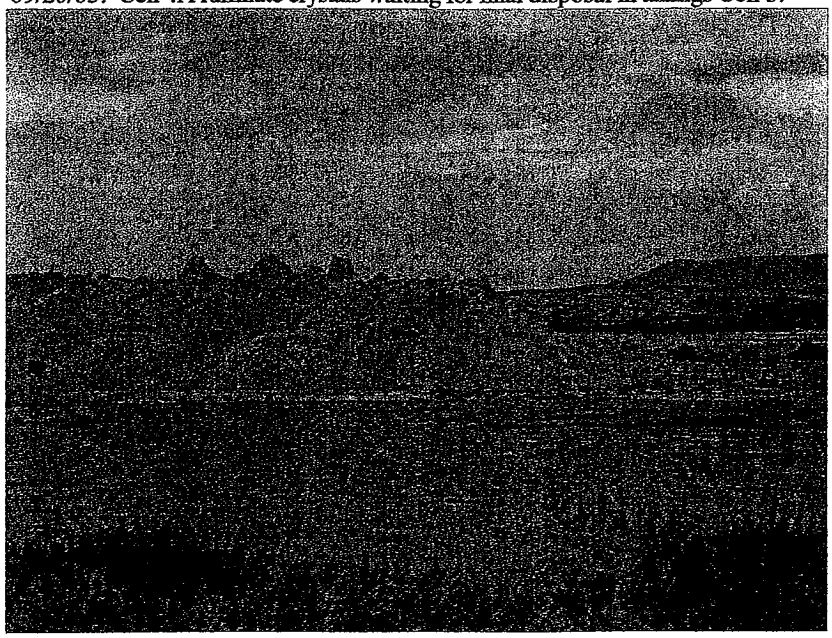
Figure 2: 09/20/05: Cell 4A raffinate crystals waiting for final disposal in tailings Cell 3.

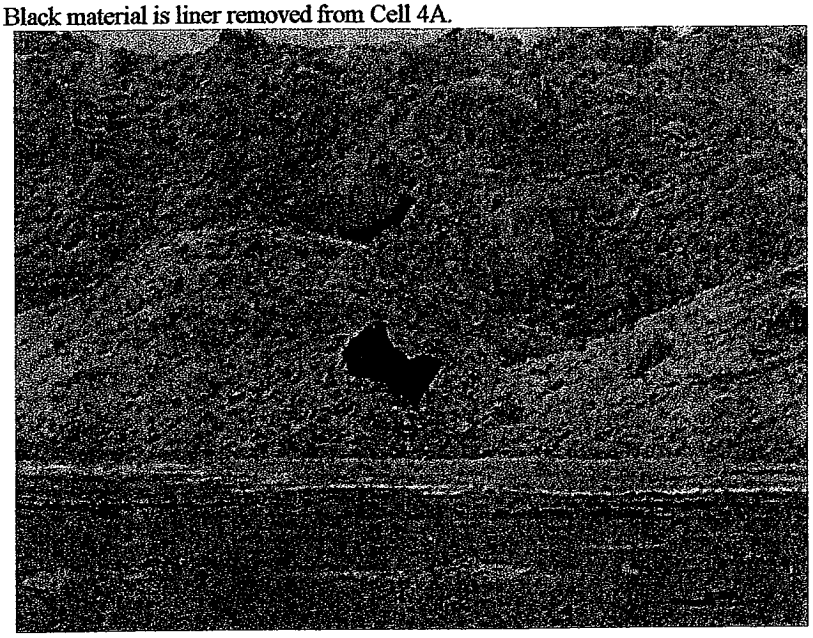
Figure 4: 09/20/05: Cell 4A raffinate crystals waiting for final disposal in tailings Cell 3. Close-up of Figure 4. Black material is liner removed from Cell 4A.

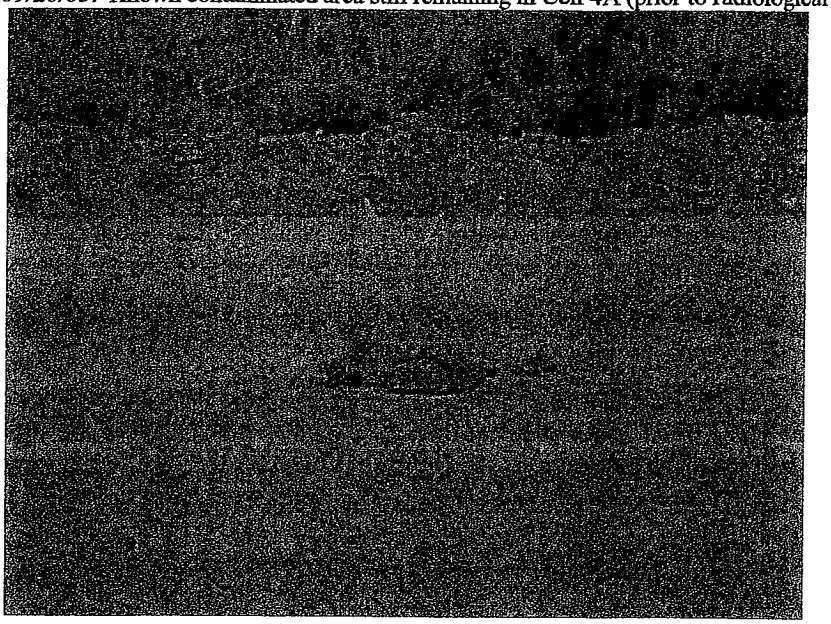
Figure 5: 09/20/05: Known contaminated area still remaining in Cell 4A (prior to radiological survey)

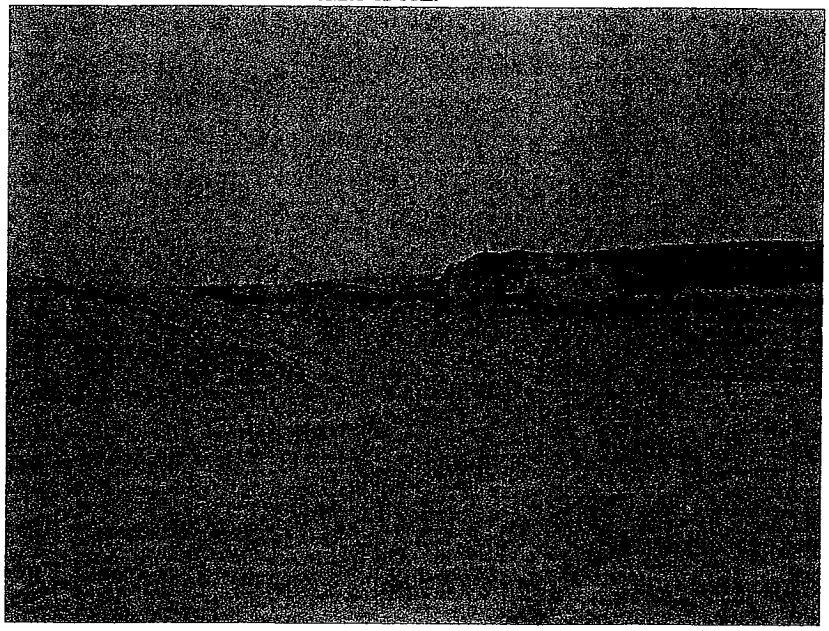
Figure 6: 09/20/05: Cell 4A northwest corner of cell.

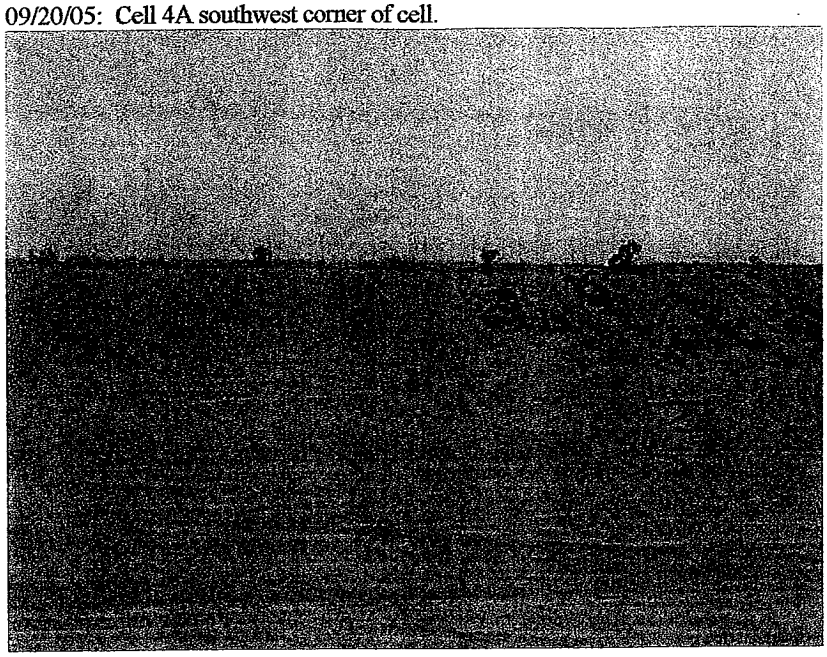
Figure 7: 09/20/05: Cell 4A southwest corner of cell.
